NACA RM H54J27

LONGITUDINAL STABILITY CHARACTERISTICS IN MANEUVERING
FLIGHT OF THE CONVAIR XF-92A DELTA-WING AIRPLANE
INCLUDING THE EFFECTS OF WING FENCES

By Thomas R. Sisk and Duane O. Muhleman

High-Speed Flight Station
Edwards, Calif.

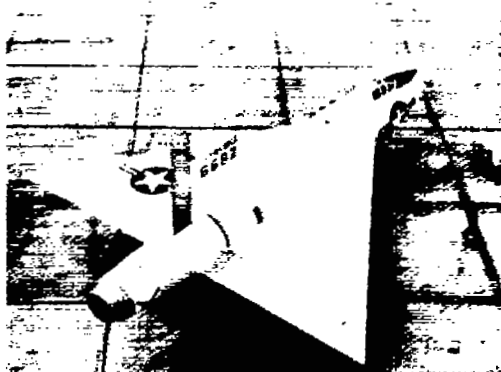
Figure 2.- Photograph of the XF-92A airplane.

The Convair XF-92A is a semitailless delta-wing airplane having 60° leading-edge sweepback of the wing and vertical stabilizer. The elevons and rudder are full-span constant-chord surfaces and are 100 percent hydraulically boosted. The artificial "feel" system provides forces approximately proportional to deflection and is adjustable in flight by the pilot. Trim is accomplished by changing the control stick position at which zero stick force is obtained. The airplane has no leading- or trailing-edge slats or flaps, no dive brakes, and no trim tabs. Table I lists the physical characteristics and figure 1 shows a three-view drawing of the airplane. Photographs are presented in figure 2.
